Ministry of Transportation
Nipigon River Bridge Independent
Technical Review

Nipigon River Bridge
Northwestern Region
Contract#: 2013-6000

September 2016

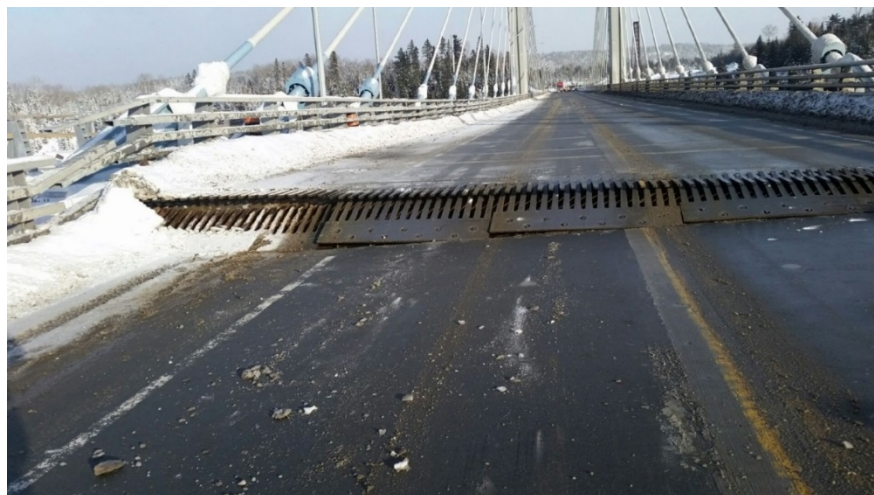
Immediately upon the failure of the bolts, the unbalanced weight of the spans, acting through the backstay cables, pulled the north-west end of the bridge deck upwards, coming to rest at approximately 600 mm above the road level. The center-west bearing did not fail, which limited further damage to the bridge.

Figure 1-1: Nipigon River Bridge, 600mm uplift of north bridge edge at west abutment, January 10th, 2016

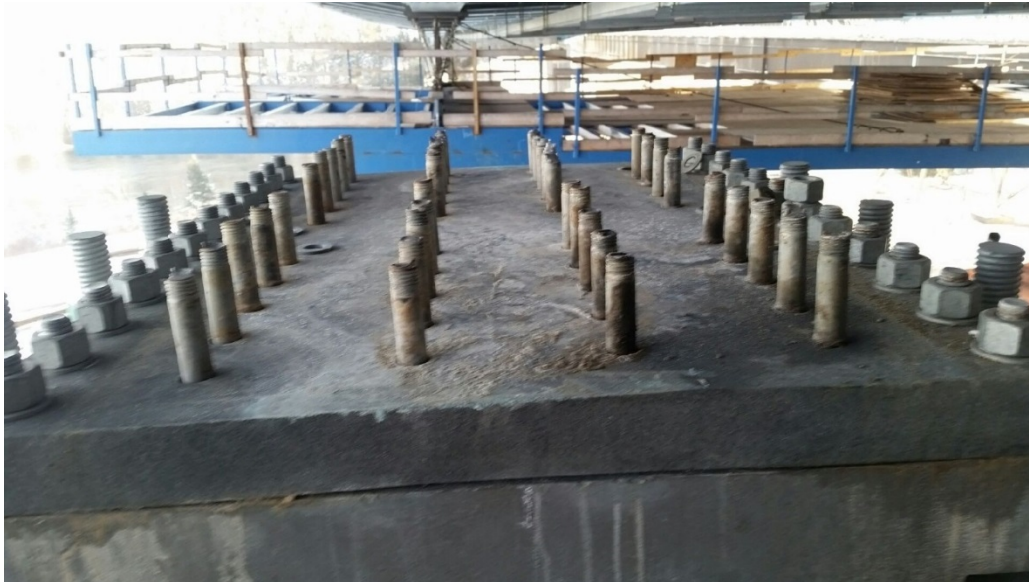
The cause of the tie down failure was a progressive fracture of the 40 (ASTM-A490) bolts connecting the bearing to the girder flange over the weeks and months prior to the complete fracture of the bolt group. While the bolt group failure was immediately apparent (as seen in Figure 1-2), the progressive nature of the bolt fractures and the contributing factors have been identified through examination and testing of the failed bolts and by the analyses and assessments described in this report.

Figure 1-2: Fractured bolts (ASTM A490 bolt - connecting shoe plate to girder flange) and deformed shoe plate at north-west bearing. Note four lines of failed flange connection bolts.

1. The bolt failure was through a progressive low-cycle fatigue fracture process induced by cyclic changes in bolt tensions in combination with localized bolt bending. The bolts were loaded in tension into the plastic range and cycled repeatedly under relatively heavy but highway legal-weight truck traffic, combined with other demands over the 42-day period following the bridge opening to traffic. As summarized below, the bolt material met specifications and was not embrittled by coatings or cold temperatures.

2. The forces and strains in the outer two lines of bolts were increased significantly by flexibility of the tapered shoe plate and related prying effects between the bearing and the girder flange. In addition to the flexibility of the shoe plate, yielding and plastic strains also occurred in the shoe plate during the bolt fracture propagation. Yielding was evident in the permanent bend of the plate following failure. Both prying effects and plastic behaviour in the shoe plate contributed to increased strains in the bolts and the progression of the bolt fractures.

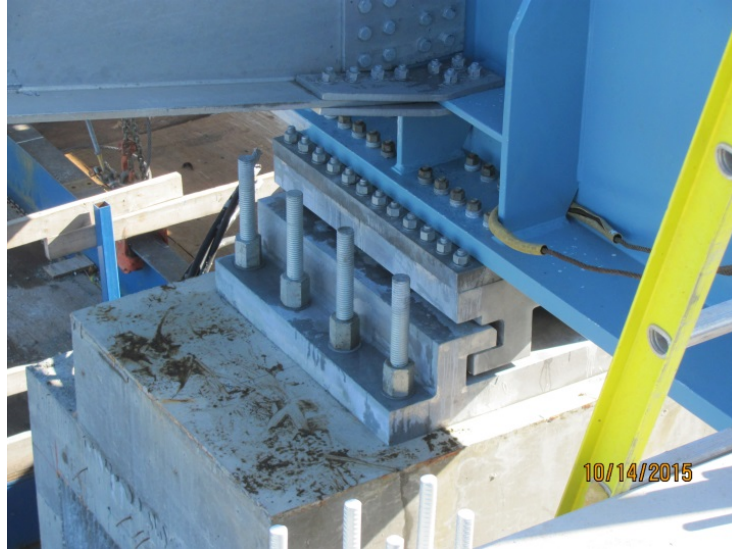
Figure 1-4: Centre-west bearing in place. Bevelled shoe plate is seen between girder flange and bearing sole plate.

The two west abutment bearings supplied had the same design uplift capacities. The north-west bearing failed, while the centre-west bearing did not. The north-west bearing has higher uplift demands at this stage of construction than the centre-west bearing, but the latter will have approximately double the uplift reaction of the north-west bearing in the completed bridge. These higher loads at the centre girder governed the bearing selection. That the northwest bearing failed at demands of only half of their maximum design demands illustrates that the bearing assembly's capacity, as affected by installation, was substantially deficient. Several conditions at the two bearings that affected bolt tensions and bolt bending could have been sufficiently different that the bolt cracking and fracture propagation had not yet occurred at the center bearing. Bolt polish marks were also observed on the intact bolts of the centre bearing suggesting that it was also experience bolt bending and was prone to a fracture similar to the north-west bearing failure.
