Nipigon River Bridge – Investigation

September 22, 2016

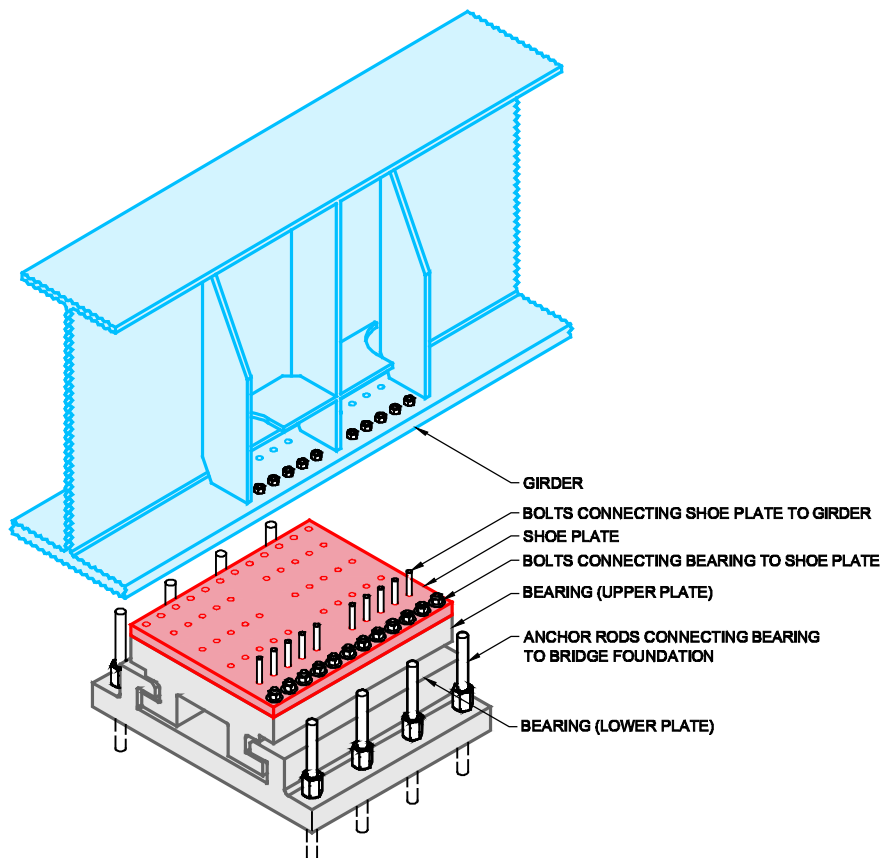
COMPONENTS

The engineering reviews found that there were three main factors that led to the malfunction: shoe plate flexibility, a lack of rotation in the bearing, and improper tightening of the bolts.

The review found that the shoe plate was too flexible, creating a “prying action” which increased the forces on the two outer rows of bolts. This additional force resulted in the bolt heads/nuts bending, stretching and eventually breaking.

The bearing did not rotate. The lack of rotation increased the forces being placed on the bolts, causing the bolts to break.

Proper tightening keeps the forces in the bolts more consistent when the load on the bridge changes.

The design of a permanent retrofit for the bridge is well underway and will be reviewed by Associated Engineering (Ont.). Please see the fact sheet Nipigon Bridge – Permanent Retrofit for more information.
